ORNL-TM- 3524

**OPERATION OF THE SAMPLER-ENRICHER
IN THE
MOLTEN SALT REACTOR EXPERIMENT**

R. B. Gallaher

OCTOBER 1971

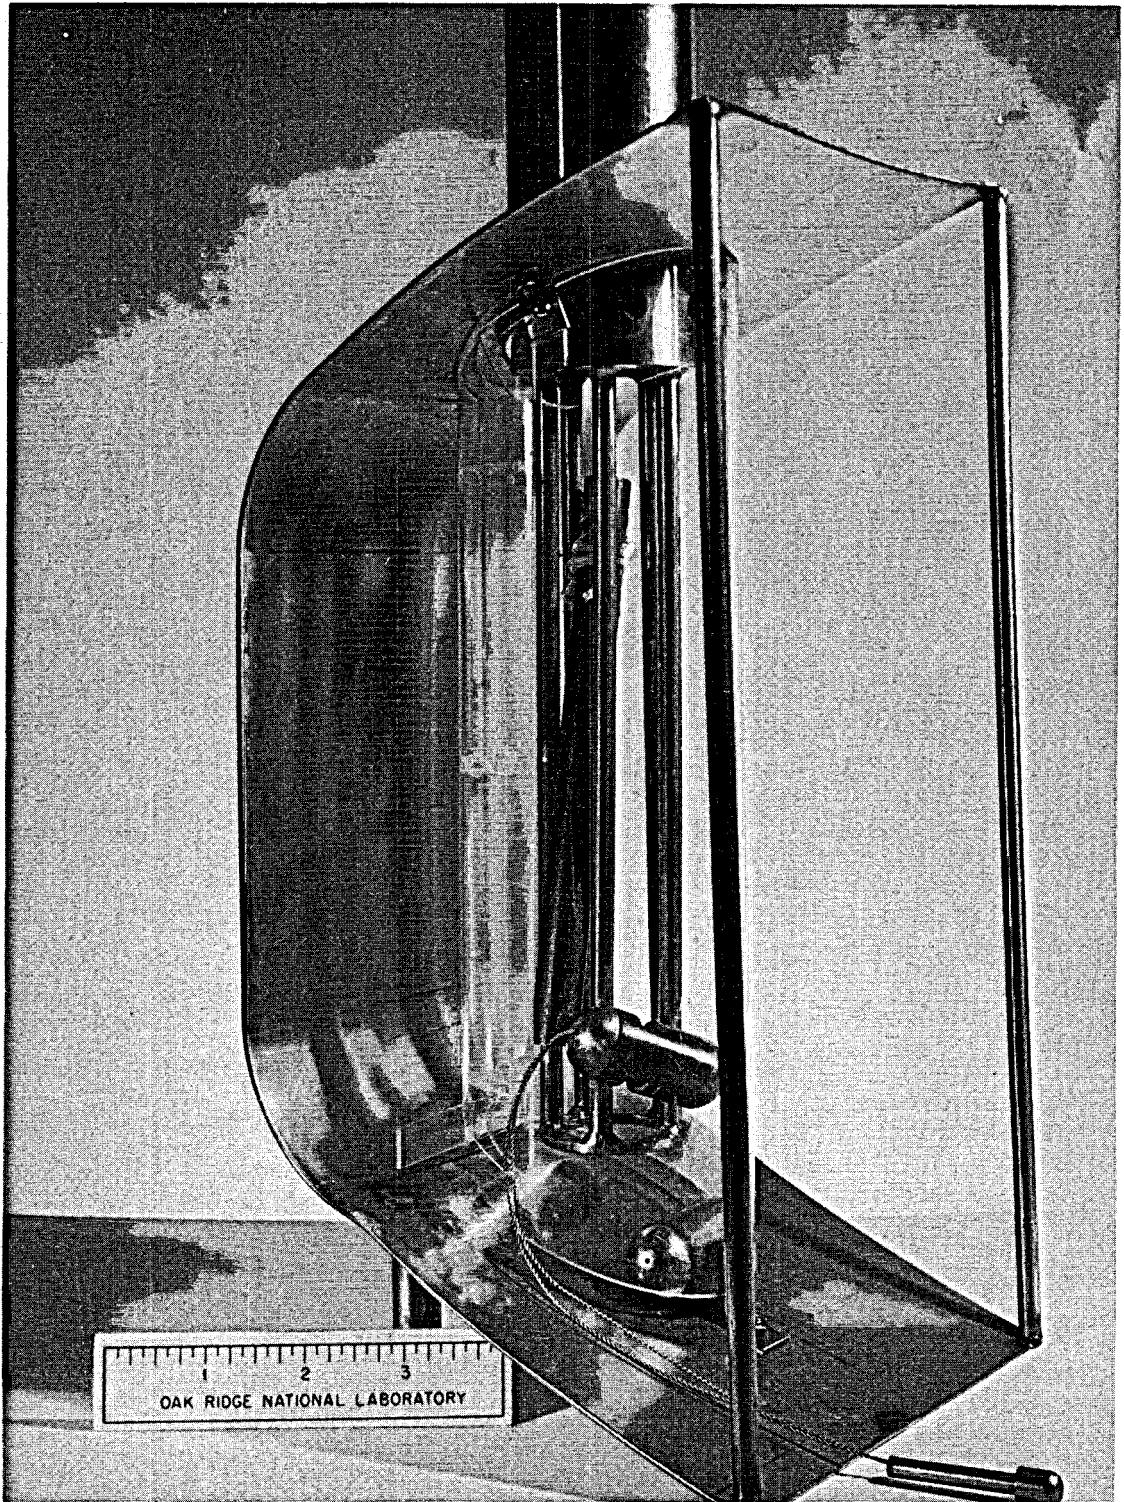
Capsules were actually dropped a few times⁸ and recovered with the magnet. While the capsule was being attached to the latch, the operational valve was closed so a dropped capsule fell only about 15 inches below the access port opening to the gate of the valve. On two occasions, noted later in the report, a capsule was dropped into the pump bowl during periods of abnormal operation when the operational and maintenance valves

Fig. 4. Mock-up Fuel Pump Bowl Section Showing Dropped Capsules and Magnet.

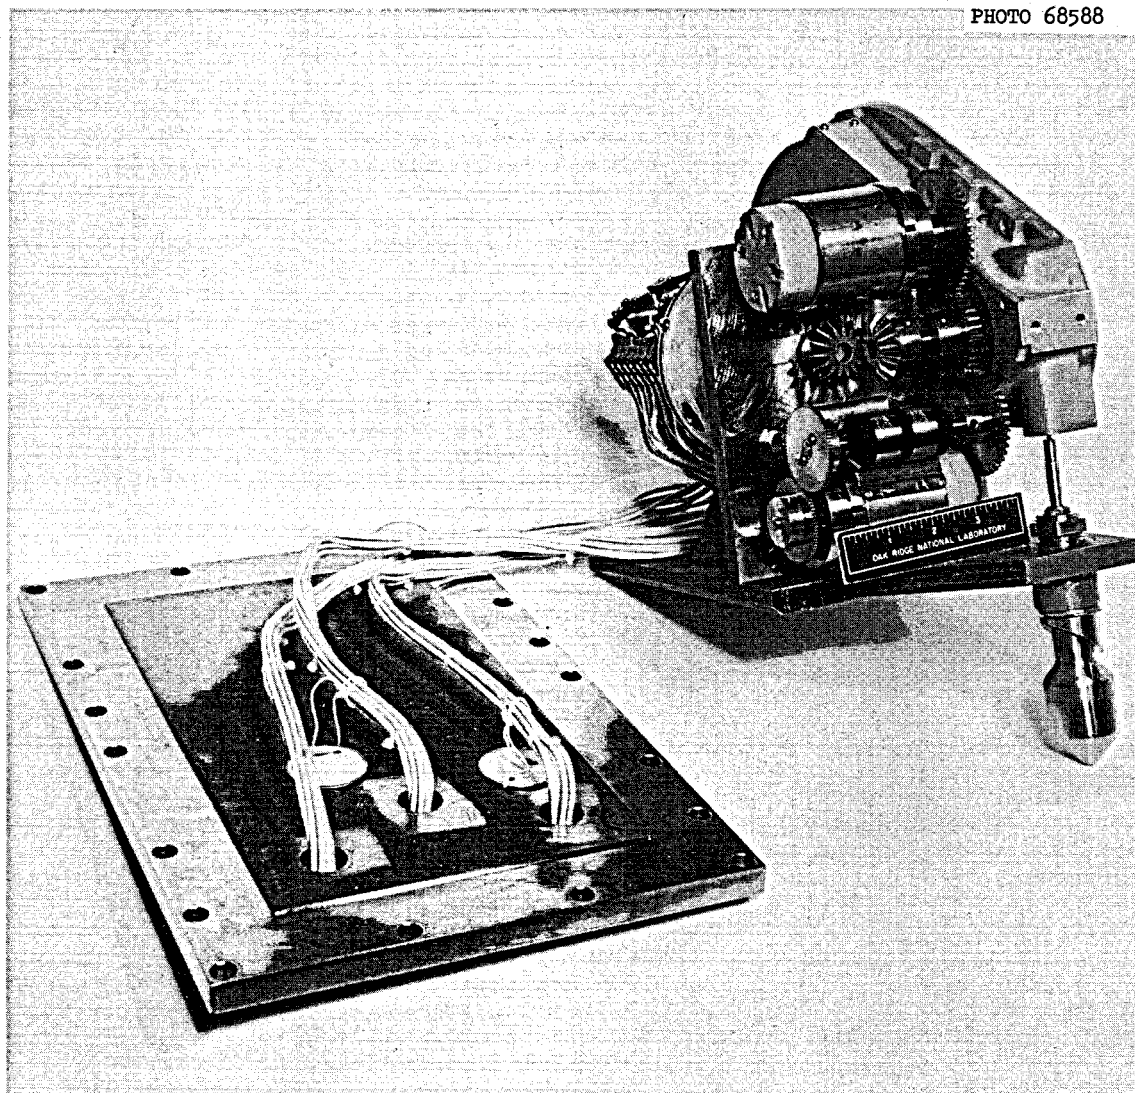
The latch attached to the end of the drive unit cable operated satisfactorily for about a year. It then started binding in the lower bend of the transfer tube. A new latch with a smaller diameter was installed. Later this latch was replaced with another one of similar dimensions, which was fabricated of 430 stainless steel instead of 304 stainless steel so that it was magnetic. The drive unit assembly is shown in Fig. 5.

One of the bevel gears connecting the cable drive unit to its motor started slipping on its shaft in December 1968 after 15 months of use. The gear was secured to the shaft by two set screws, but the repeated stress placed on the unit while attaching the capsule and checking it probably loosened the screws and caused the gear to slip on the shaft. Also, just prior to this difficulty, a key had jammed in the latch. Extra strain was applied to the drive unit while trying to remove the key from the latch with the manipulator. Slipping was first noticed while attempting to free the key.

Fig. 5. Drive Unit Assembly.

To repair the gearing, the 1C assembly was lifted above the top of 3A. This required draining the reactor and removing two top shielding

blocks to reach the bolts of the flange located at the lower end of 1C. Next, a 3-in.-diam hole was drilled through the 1/2-in.-thick wall of the drive unit box at a point adjacent to the gears. When the motor was operated, the gear on the drive unit was observed to slip on its shaft. Using a long-handled wrench, both set screws were tightened, but the gear still slipped. It was then welded to the shaft. Both set screws on the mating gear on the motor shaft were tightened and locking screws were installed to hold them in place. A plug was then welded over the hole in the containment box. At the start of this repair operation the radiation level at the gears was 45 R/hr. At the outside of the containment box where the hole was drilled it was 27 R/hr.

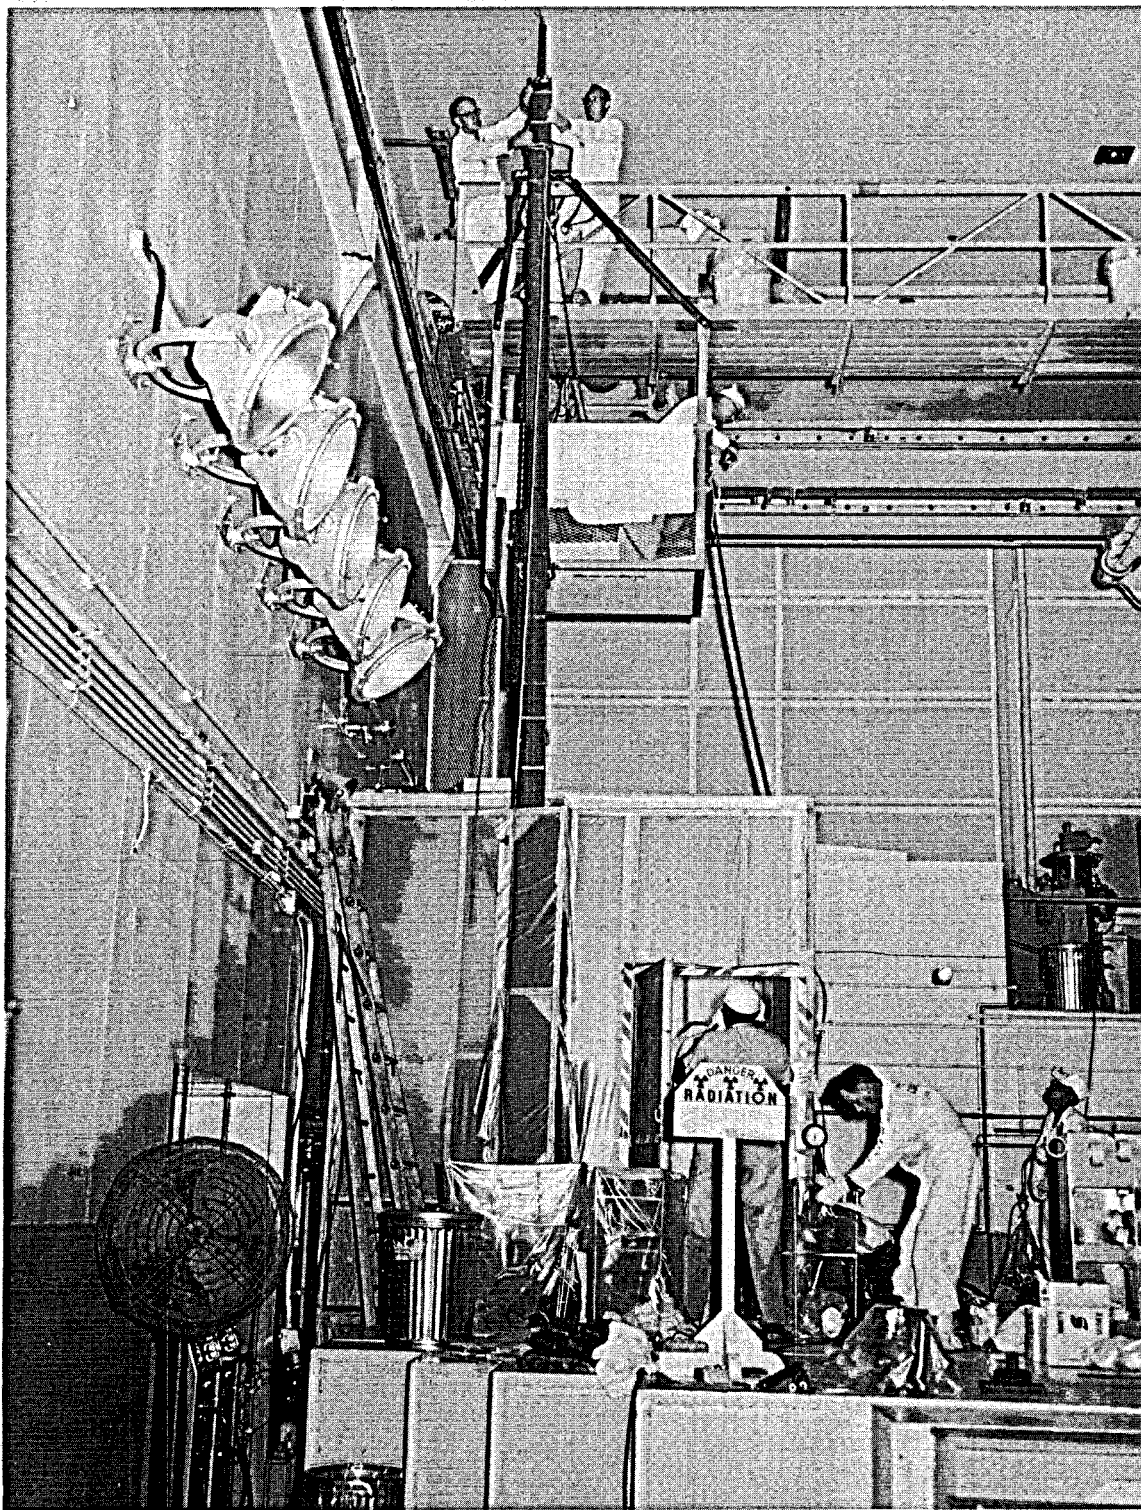
The fifth time the drive unit malfunctioned no attempt was made to close the operational valve as we did not want to chance cutting the cable again. The reactor was drained so that the access port could be

Fig. 6. Tools and Tent Used During Recovery of Lost Latch.

opened to observe the condition of the cable. This was the first opportunity for a visual inspection of this type of trouble. The capsule was seen lying on its side on the lower ledge of the access port opening. The latch was above and behind it. The cable formed many coils. The normal position of the capsule when attached to the latch was about four inches below the place where it was observed. No explanation was found for its observed location. While attempting to grasp the capsule with the manipulator, the operator brushed against one of the coils of cable shifting the position of all parts. The latch fell on its side allowing the key to slip out of it and the capsule to drop into the pump bowl.¹² The capsule recovery attempt with magnets was described in a prior section.

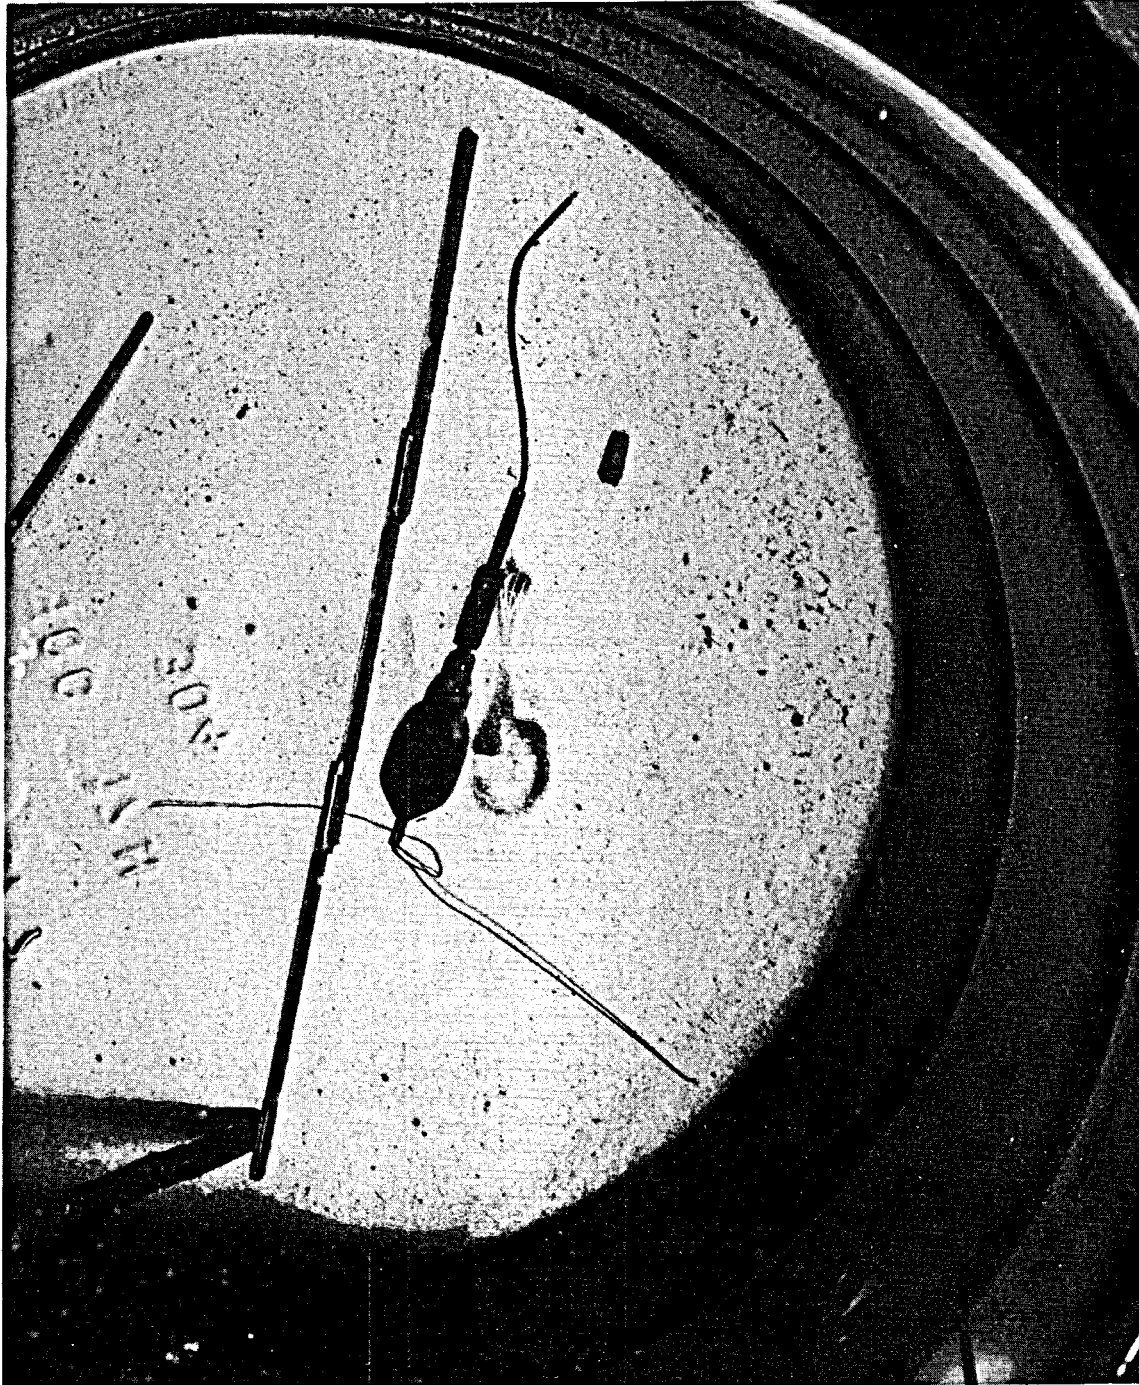
Fig. 7. Latch and Key After Removal from Transfer Line.

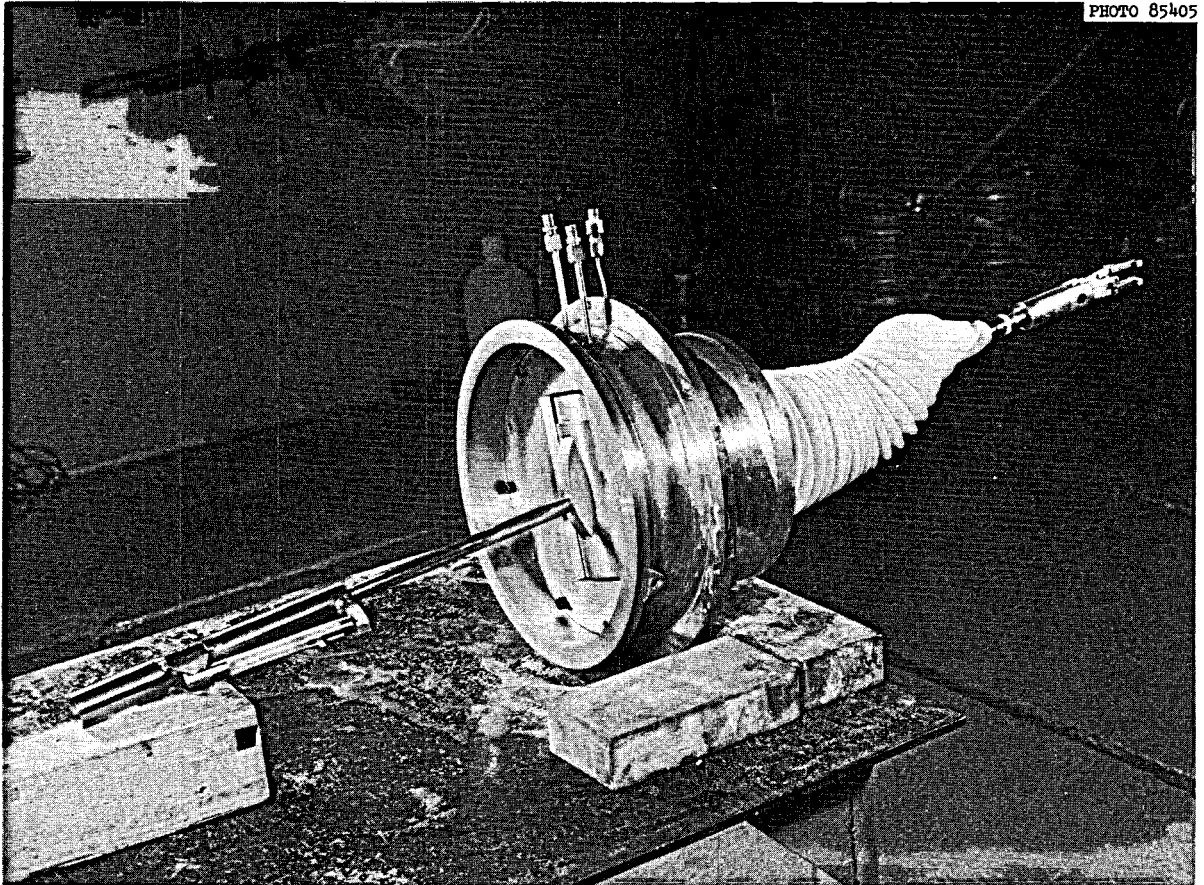
The manipulator (Fig. 9) required more maintenance than any other component of the sampler-enricher. The two-ply polyurethane boots which sealed the arm to the wall of 3A had to be replaced 17 times or an average of 3-1/2 times a year. After standard maintenance procedures were established, the estimated cost per change was \$1,800.¹³

During design the plastic boots were recognized as a potentially weak member that might rupture under the 40-psi design pressure conditions. Therefore, a cover was kept over the operator end of the arm except during periods when the manipulator was in use. The cono-seal flange that sealed the cover to area 3A was easy to open, but awkward to close because of the crowded conditions around the flange location.

Fig. 9. Manipulator Assembly Without Cover.

Improvements in boot design were made throughout the operating period. The first major modification was the addition of steel rings to the convolutions of the inner boot. This prevented the boot from collapsing against the arm when there was a pressure differential across the boot with the higher pressure in 3A. When the boot collapsed, movement of the arm abraded and pinched the plastic. Also, friction made the in-and-out movement of the manipulator difficult.

When the differential pressure was in the opposite direction, two problems arose from the ballooning of the boots. Some of the steel rings in the inner boot slipped out of the convolutions. The displaced rings pinched holes in the boot after a period of use. During early sampling cycles prior to operating the reactor at power, the pressure differential blew the boots off their flange on 3A. Improved clamping arrangements prevented this from recurring. Also, a differential pressure switch was installed to protect against excessive pressure differentials in the direction that caused ballooning.

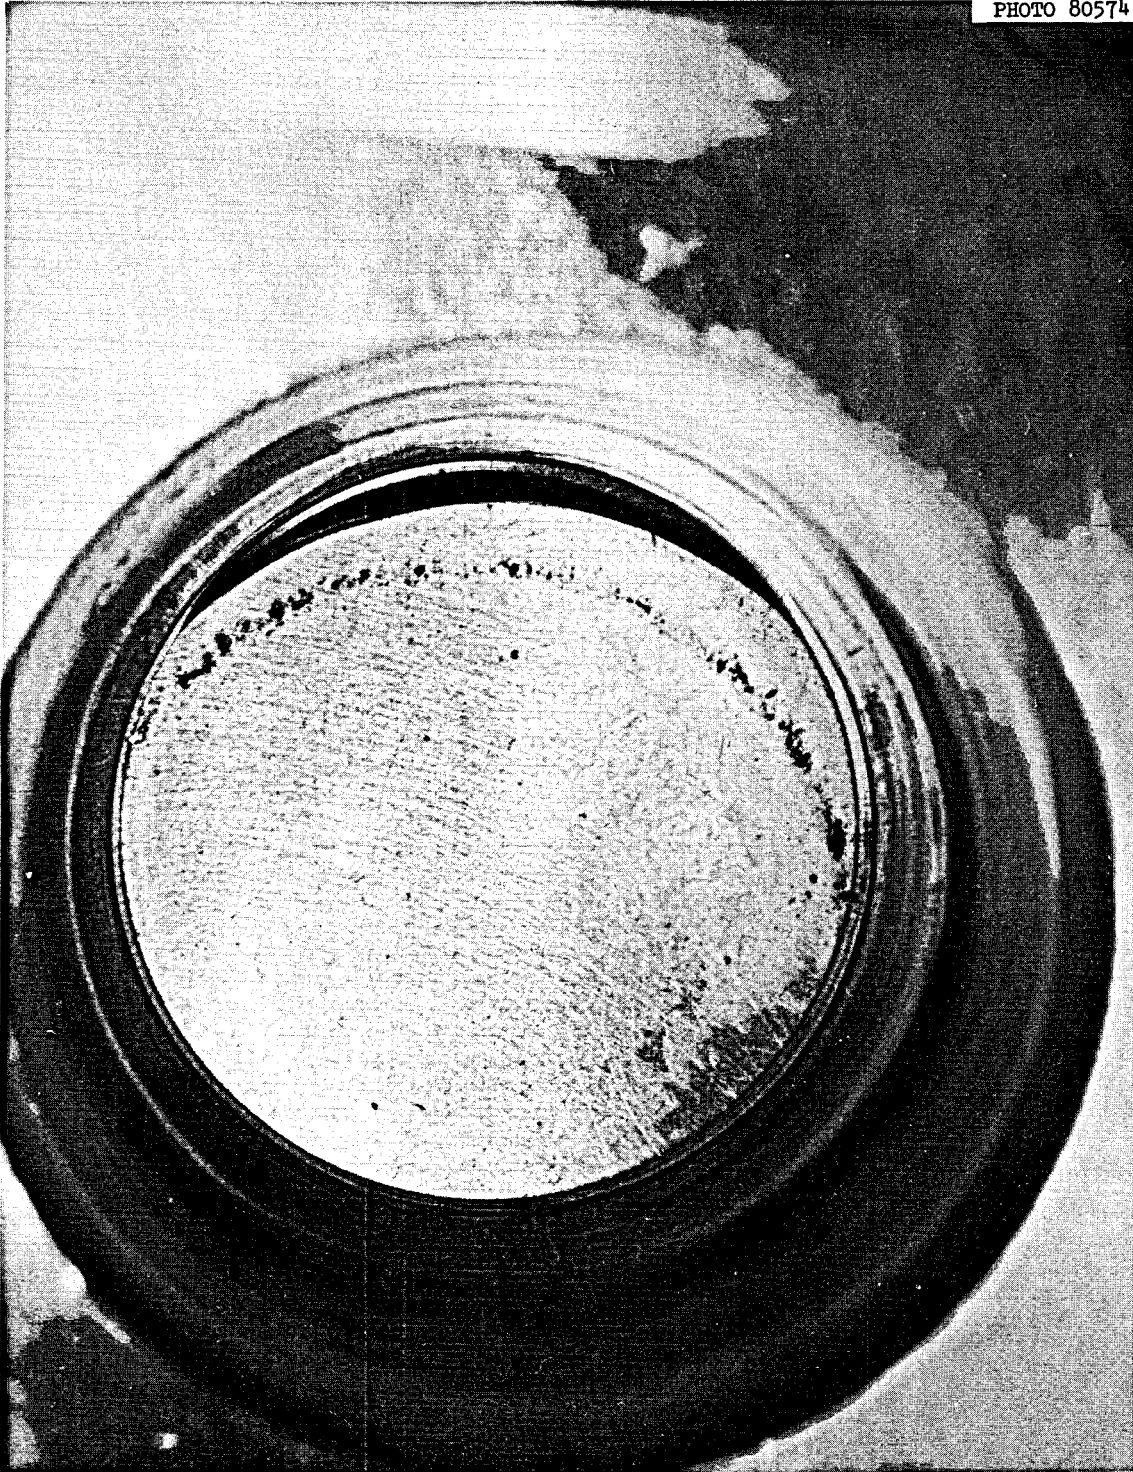
PHOTO 80574

The Stellite-faced gates of the operation and maintenance valves were lapped until they fitted against the Stellite-faced seats located on each side. Before installation in the sampler, the leak rate from the buffer zone across both seals was <1 cc/min at 40 psi pressure differential for each valve. During use a small amount of foreign material accumulated on the upper face (see Fig. 10) of the gates, increasing the leak rate. After the first run and before power operation, the gates were cleaned by wiping them with a damp cloth. The leak rate then decreased to less than 1 cc/min again, but gradually increased with use as dirt particles accumulated again. After power operation, the high-radiation level prevented recleaning. Initial plans called for the use of only the operational valve during normal operations, with the maintenance valve as a backup in case the operational valve failed and for use during periods of maintenance on other components of the sampler. Both valves were used routinely as an added precaution against the accidental release of gaseous activity from the pump bowl.

Fig. 10. Dirt on Gate of the Operational Valve.

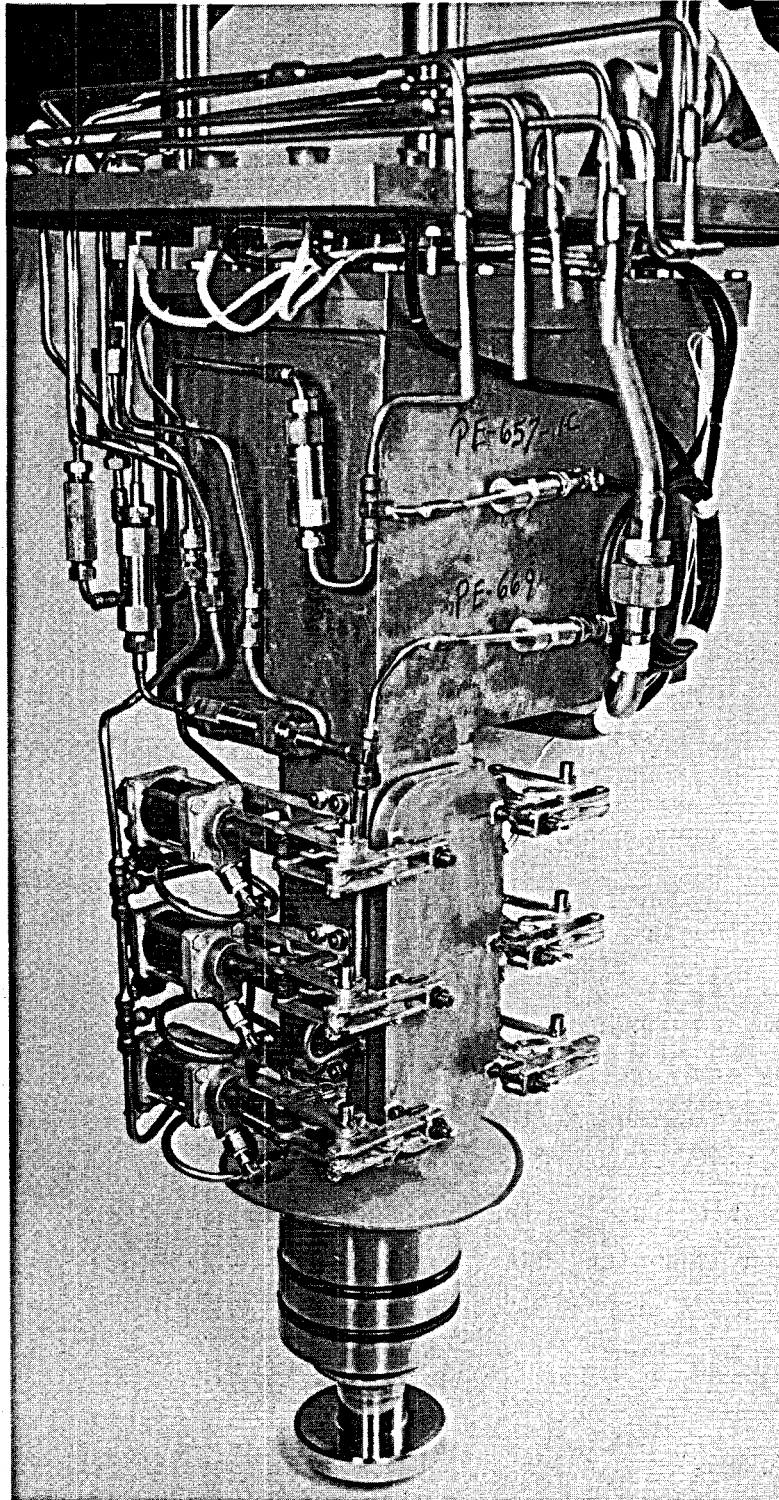
When 1C was pressure checked at 48 psig after installation, the load on each clamp was about 270 pounds. For the configuration used, the clamps were rated for a load of about 300 pounds. The loading that occurred during pressure testing loosened the link pins slightly and reduced the pressure exerted on the gasket, thus increasing the leak rate through the seals. Prior to installation of the 1C assembly, the access port leak rate was less than 1 cc/min at 40 psi differential. After use, it increased by more than a factor of ten.

During one sampler-enricher maintenance period when the access port, the operational valve, and the maintenance valve were all open with the reactor at 1/2-psig pressure, a small quantity of radioactive gas was

Fig. 12. 1C Assembly with Access Port Closed.

released to the building ventilation system. The gas leaked past the O-ring seal on one of the Knu-Vise cylinder rods. After this incident, a small charcoal trap was installed in the vent line from the cylinders and a valve in the line was left closed except during use of the access port. No further releases were detected.

On the second area 1C assembly, the Knu-Vise clamps were modified so that they could be semi-remotely adjusted to increase the pressure on the gasket while installed. However, the radiation level in 3A was so high (more than 100 R/hr at the manipulator port) that very little adjusting was done.

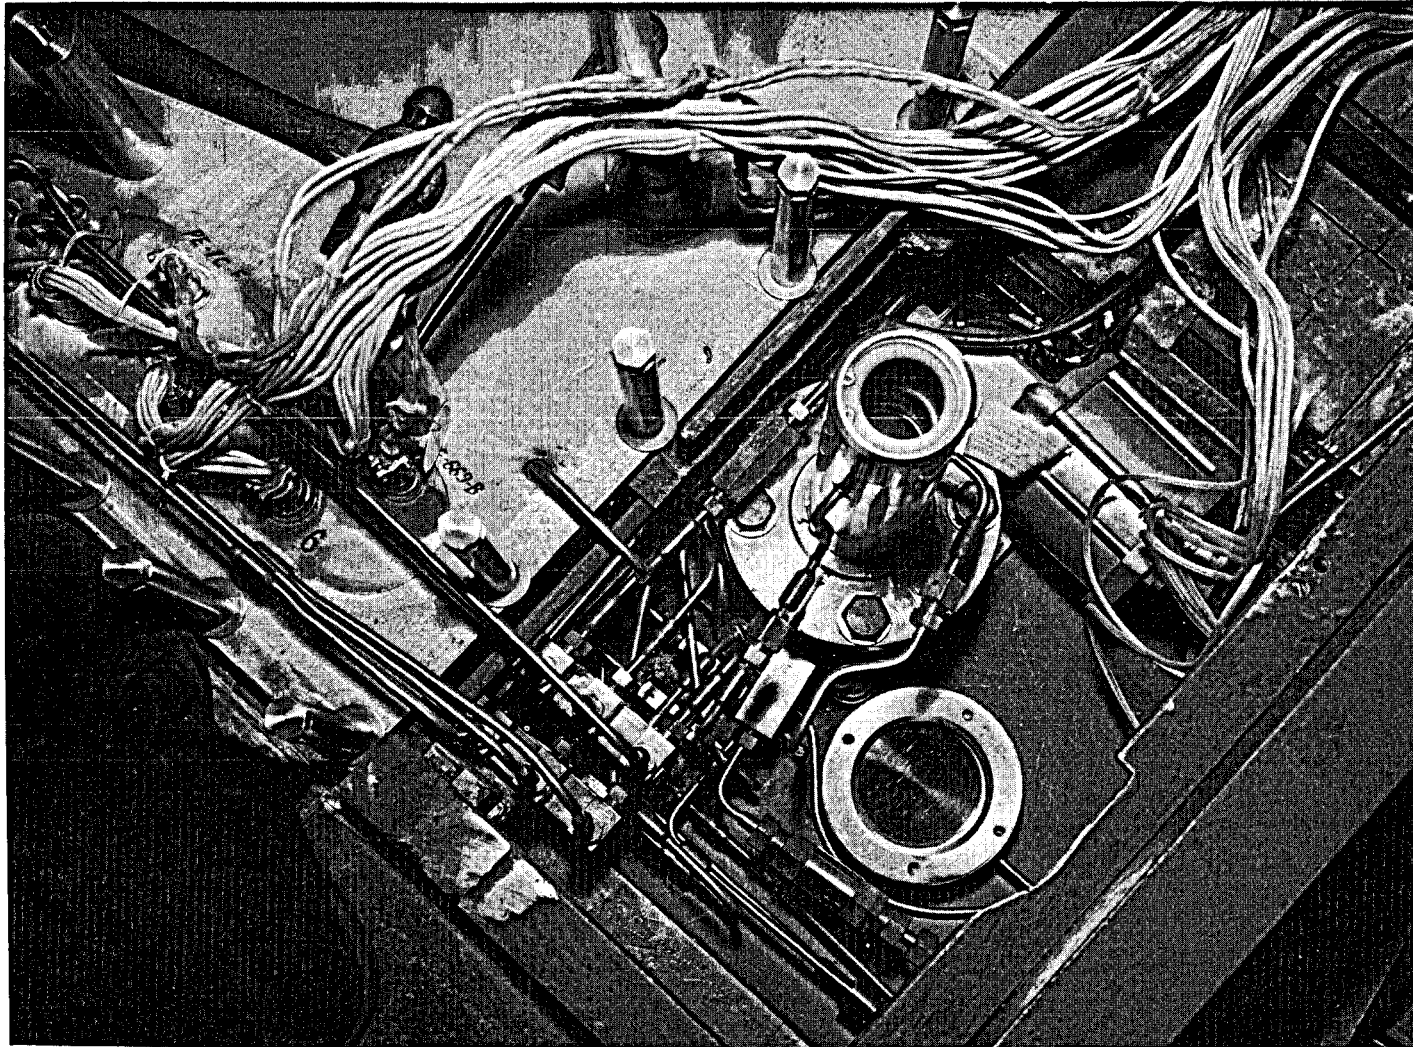
PHOTO 81698

The Teflon body and stem seals in the ball valve (removal valve) located above 3A showed little or no detectable radiation damage. Some leakage from the buffer zone to the atmospheric side of the valve resulted when particles on top of the ball caught on the seals when the ball was rotated. Pressure on the body seals was adjusted several times without removing the valve from the system. Also, the upper seal was replaced once.

The mounting bracket for the air cylinder operator was not sturdy enough to prevent movement of the cylinder on the valve body which limited the maximum torque that could be applied to the ball by the cylinder. However, the crowded conditions in this region prevented tightening the bracket bolts without removing several components. A top view of this area is shown in Fig. 13.

Fig. 13. Top View Showing Removal Valve Area.

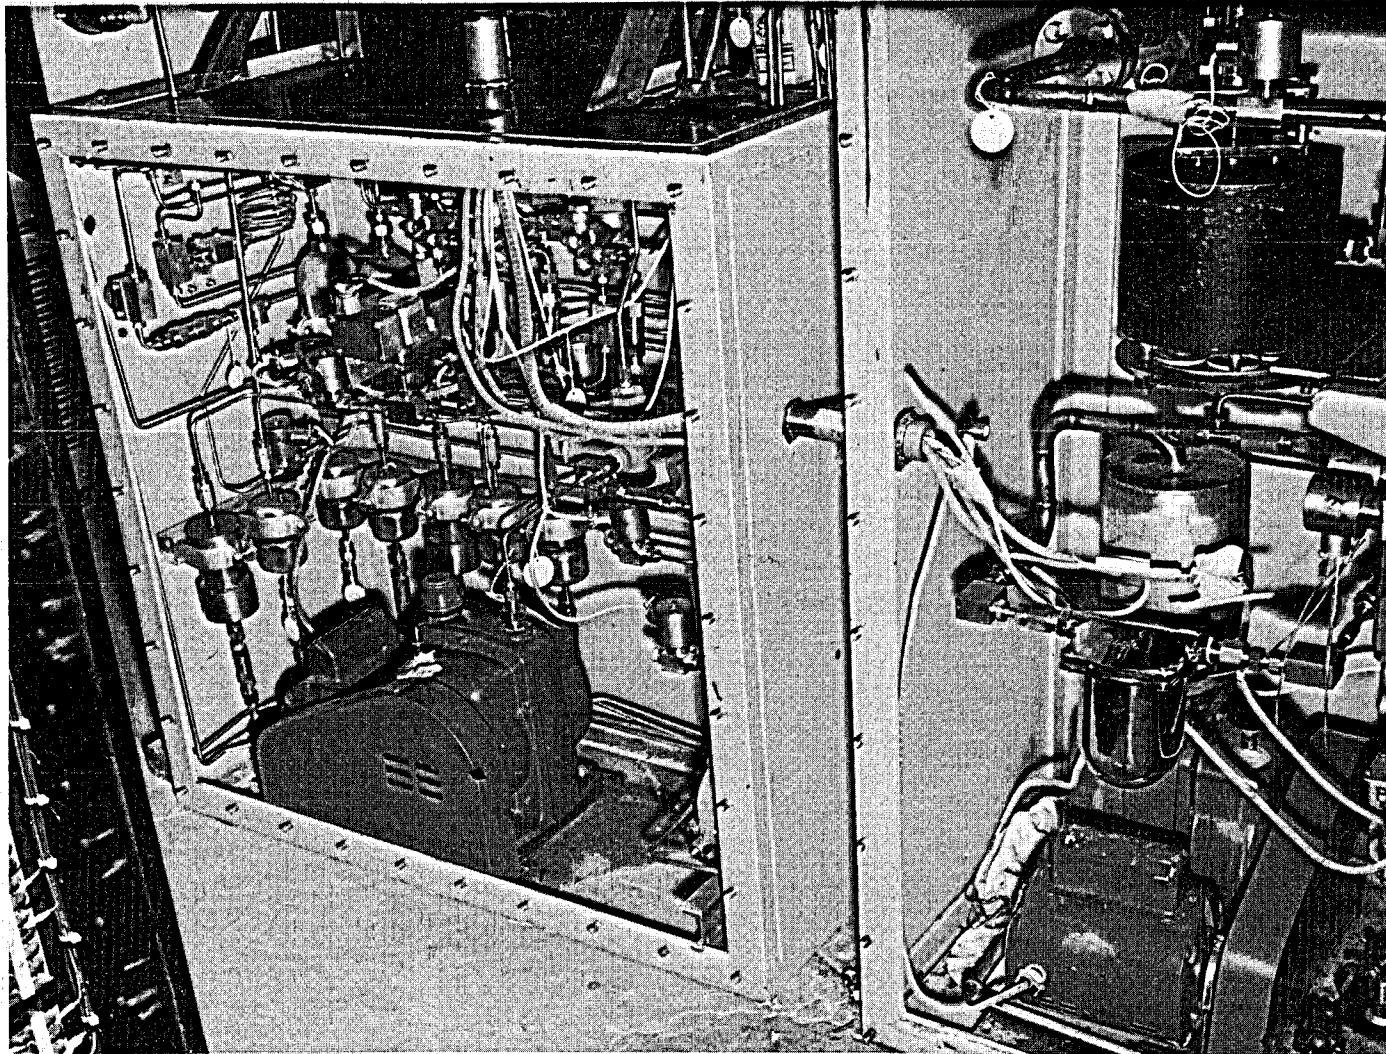
PHOTO 69408

Two vacuum pumps (Cono Hyvac) were used in the off-gas system. The discharge of one pump which was exposed to helium containing gaseous fission products was connected to the auxiliary charcoal bed. The shaft seal in this pump was improperly installed as received and had to be replaced after a few months of operation. The belt was also replaced once. Just a few months prior to shutdown, the unit was replaced rather than repaired because of the radiation level and contamination associated with it. No radiation damage was apparent to the oil. Because of space limitation the oil level in the pump was hard to determine. Once the pump failed to operate properly because the oil level was too low. Oil was added several times. Figure 14 shows the two pumps. The one on the right was the one exposed to contamination.

Fig. 14. Hot Vacuum Pump (Right) Cold Vacuum Pump (Left).
