EVALUATION OF HASTELLOY N ALLOYS  
AFTER NINE YEARS EXPOSURE TO BOTH  
A MOLTEN FLUORIDE SALT AND AIR AT  
TEMPERATURES FROM 700 TO 560°C

**METALS AND CERAMICS DIVISION**

DECEMBER 1972

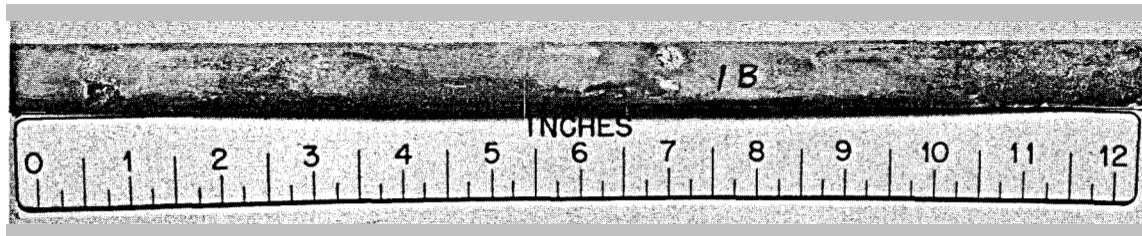
PHOTO 70514

Fig. 4. Corrosive attack on exterior of Hastelloy N tubing underneath ceramic bushings after 552 hr at 675 to 785°C.

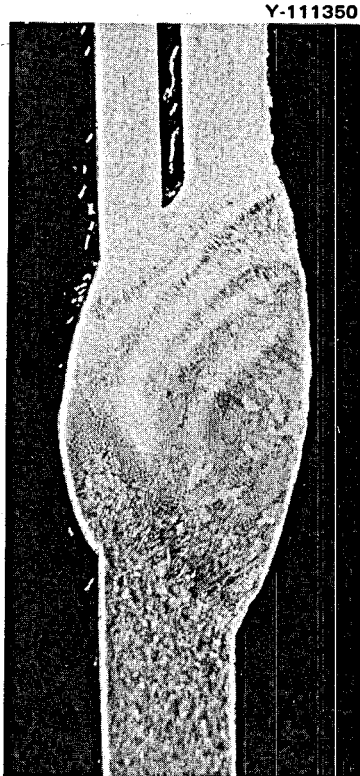
Fig. 29. Weld joining standard Hastelloy N tubing (top, right) and spacer (top, left) to modified Hastelloy N-2% Nb tubing (below). Left side exposed to salt at 665°C; right side exposed to air. Etched with glyceria regia. 12X.
