ORNL-TM- 3524

**OPERATION OF THE SAMPLER-ENRICHER
IN THE
MOLTEN SALT REACTOR EXPERIMENT**

R. B. Gallaher

OCTOBER 1971

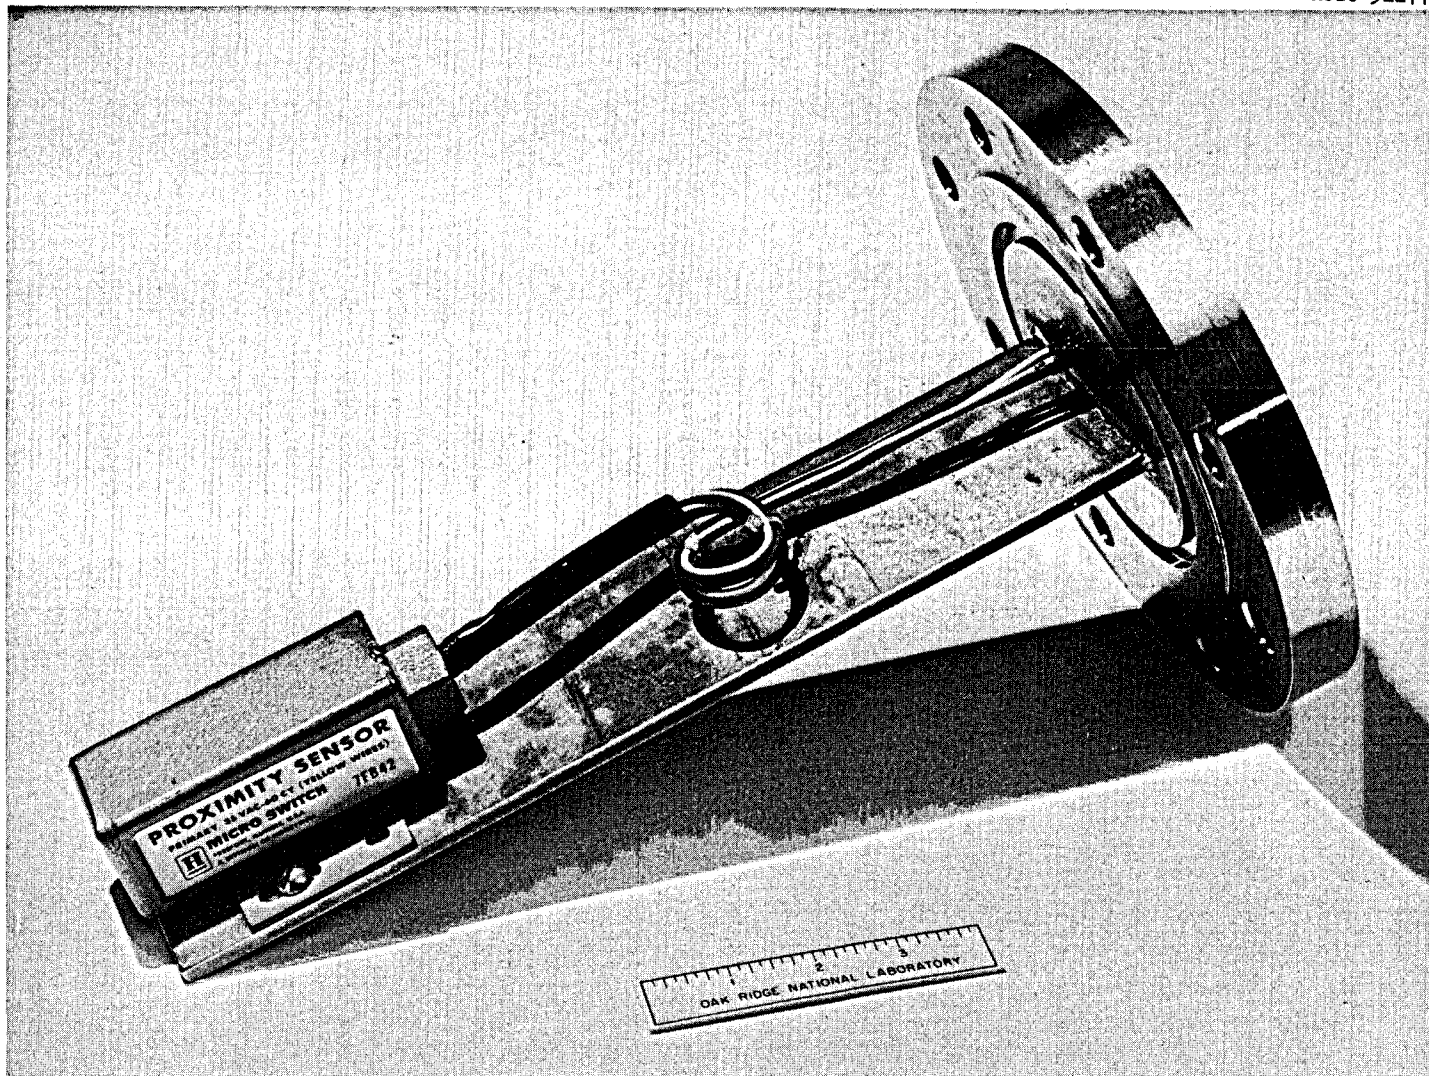
Fig. 8. Proximity Switch Assembly.

While the reactor was drained a proximity switch, shown in Fig. 8, was mounted on the transfer tube between the maintenance valve and the floor of the containment box. This unit could detect the movement of the magnetic latch past this point, thus indicating that the capsule and latch had indeed entered the transfer tube. This switch was obtained immediately after the fourth hangup occurred and was awaiting a reactor shutdown for installation when the fifth hangup occurred. Several malfunctions were detected by the switch and were corrected before difficulties occurred.

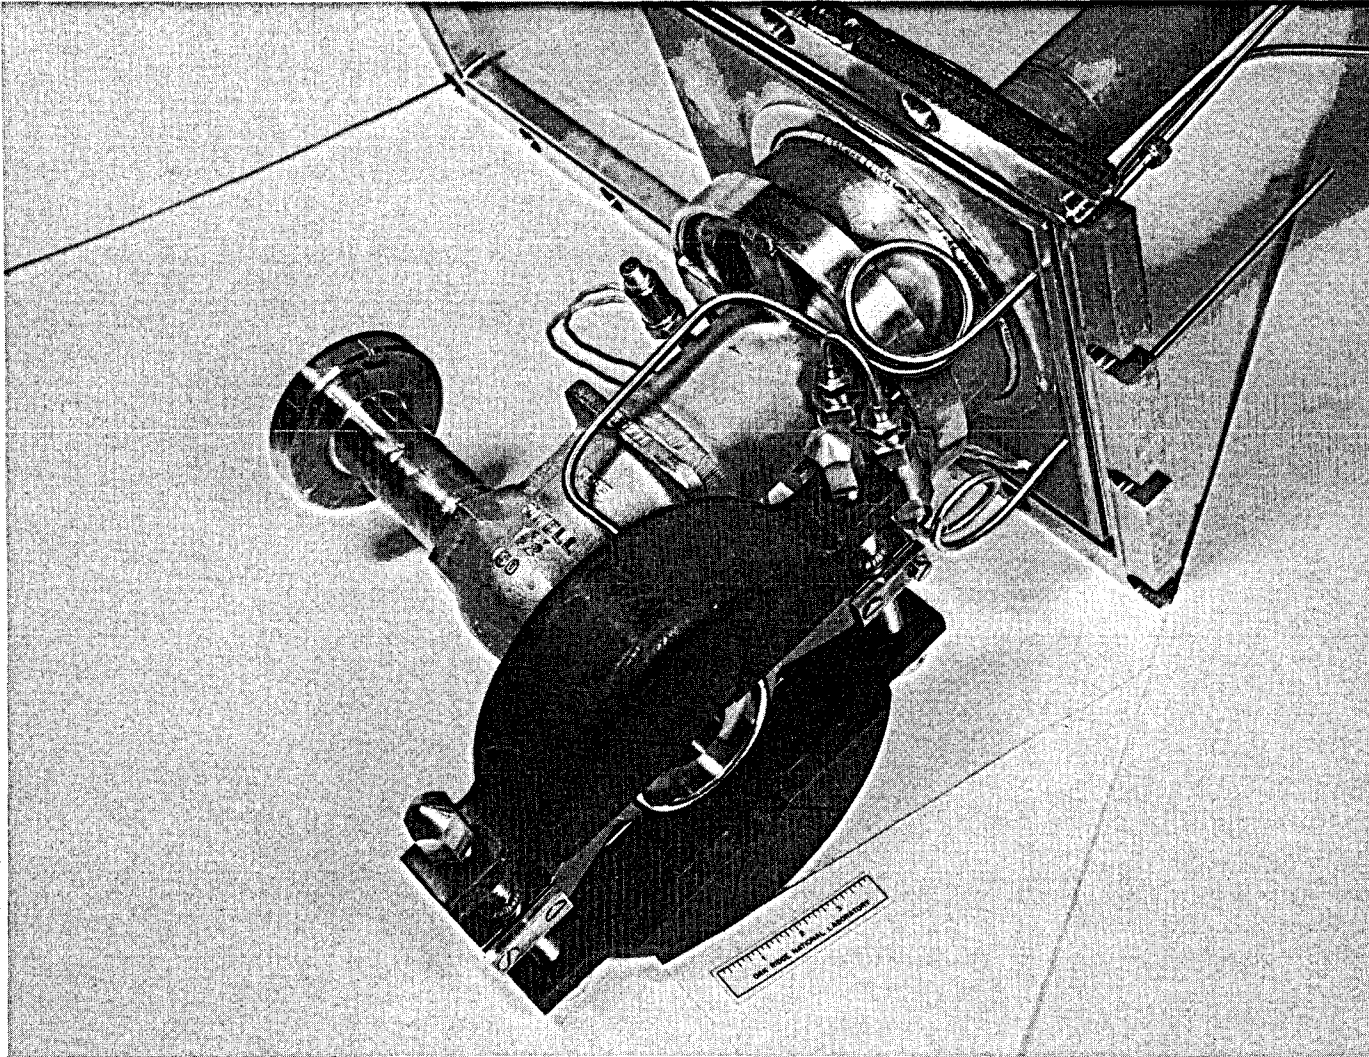
Fig. 11. Operational Valve Assembly.

Special ring-joint spring-clamp disconnects¹⁴ developed at ORNL for remote maintenance usage were chosen for the valves. Figure 11 shows the operational valve with the flanges and a pair of spring clamps. For this application each flange half was fabricated individually using a set of master gages as guides instead of the previously used method of machining two halves to match each other. The change was necessary to permit replacement of components. When the new IC assembly was installed, a new flange half was mated with a used one for the first time. A leaktight ($<10^{-4}$ cc He/sec) joint was obtained.
